Building Inspection Report

1234 Somewhere Dr. City, FL

A Thorough Inspection Inc.

08162009

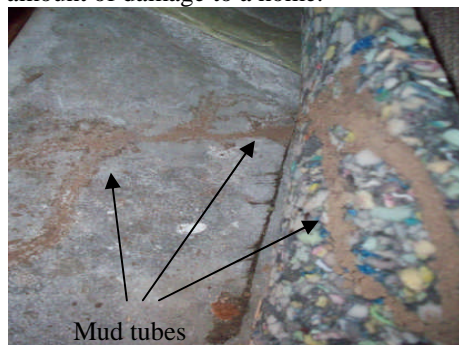
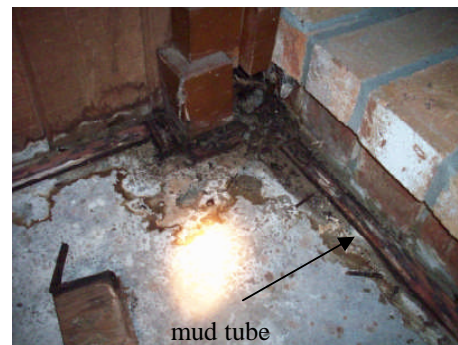
Wood Boring Insects

- **Repair/Improve:** Evidence of termite activity was observed in front of the fire place and to the left side. There is risk of additional hidden damage. If the property has not already been treated, a licensed pest control specialist should be engaged. Termites can do a substantial amount of damage to the wood structural components of a home. Termites can do a substantial amount of damage to a home.

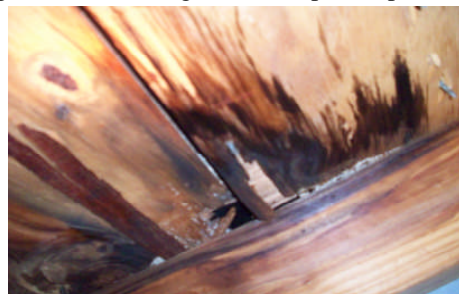
Roof

- **Repair:** The roof sheathing is delaminating (deterioration caused by moisture (old leaks)) in various locations. In most cases, damaged roof sheathing must be replaced prior to re-roofing. Damaged sheathing should be replaced when re-roofing.

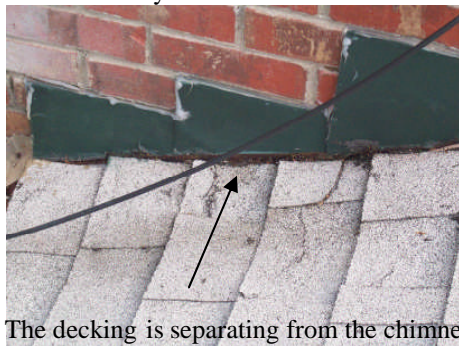
- **Repair:** The roof leaks around the fire place and should be patched. If this is unsuccessful, replacement will be necessary. The wood is very soft on the left side of the fire place.

The decking is separating from the chimney.

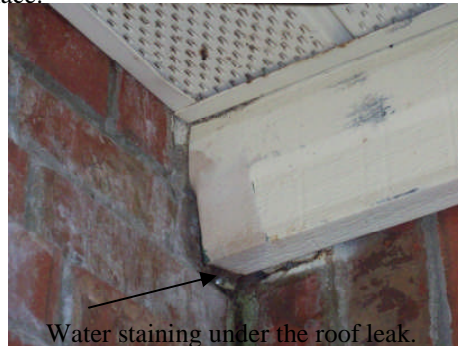
Water staining under the roof leak.

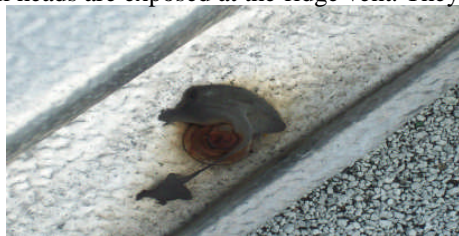
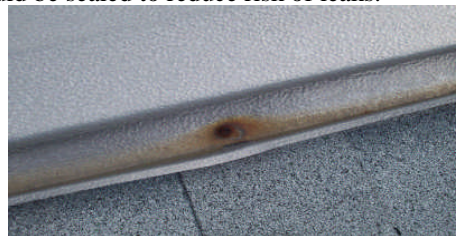
- **Repair:** Nail heads are exposed at the ridge vent. They should be sealed to reduce risk of leaks.

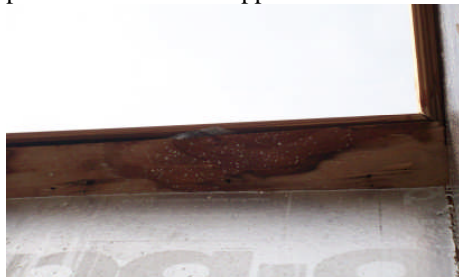
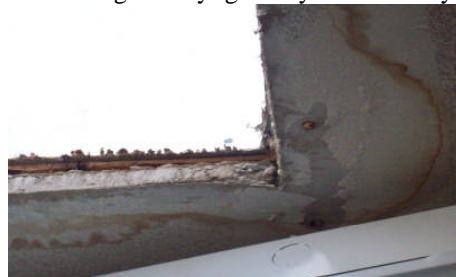
- **Repair:** The skylight shows water stains on the wall board around the base of the skylights. In some cases, patching the flashing will prevent leaks. If this approach is unsuccessful, re-installing the skylight may be necessary.

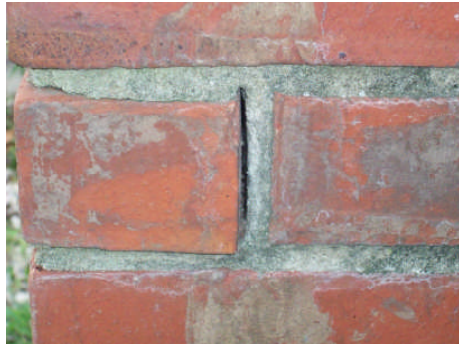
Chimneys

- **Repair:** The masonry chimney needs some re-pointing (replacing the mortar between the bricks) to avoid water damage.

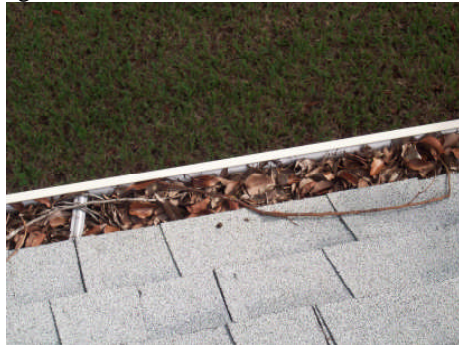
- **Repair:** The gutters require cleaning to avoid spilling roof runoff around the building – a potential source of water entry or water damage.

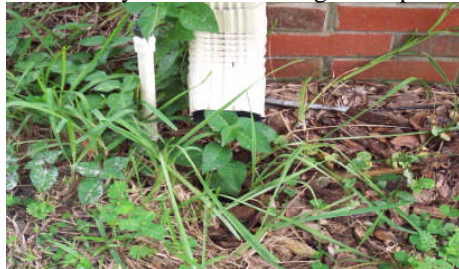
- **Repair:** The downspout(s) should discharge water at least five (5) feet from the house. Storm water should be encouraged to flow away from the building at the point of discharge.

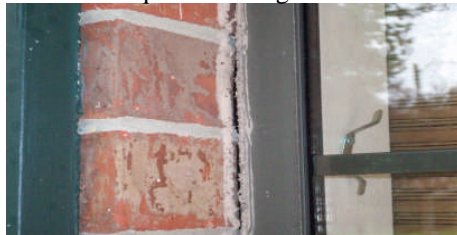
Windows

- **Repair:** The windows require caulking.

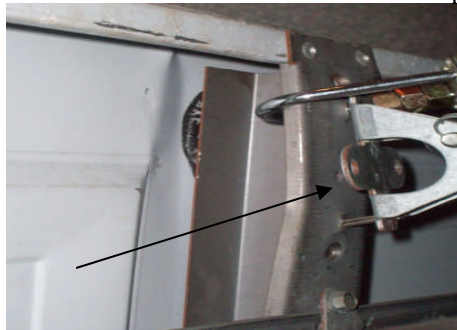
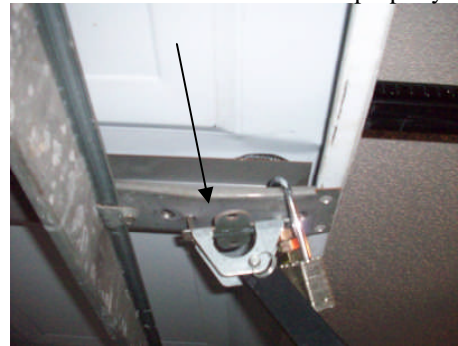
- **Repair:** The bracket that attaches the automatic door opener to the door needs to be attached properly.

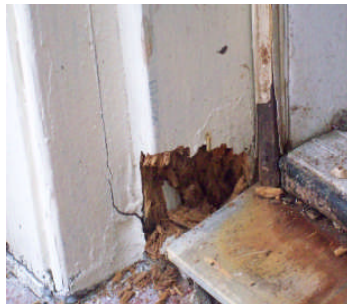
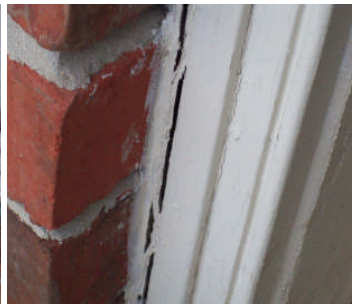
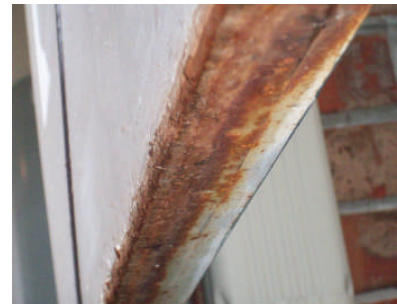
- **Repair:** The garage door opener is unplugged and the button to open it is missing. It should be repaired as necessary.
- **Repair:** The service entrance door trim has decay on the bottom of both sides. The casing also needs to be caulked. The door has rust on the bottom.

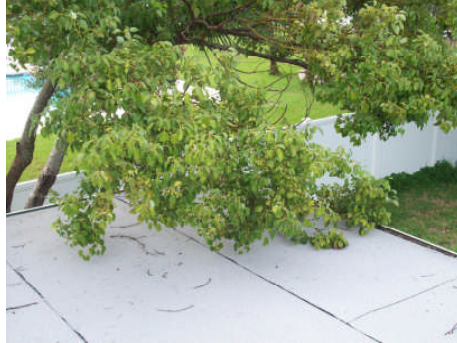
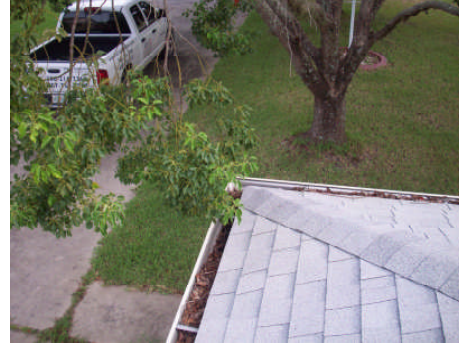
- **Repair:** Tree branches should be trimmed away from the house to avoid damage to the building.

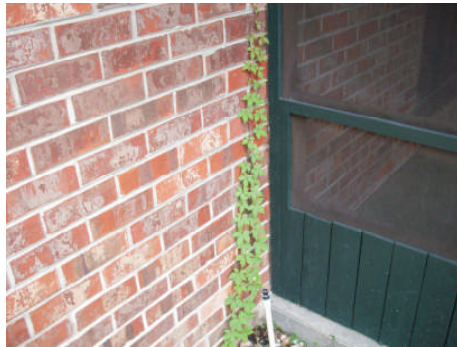
- **Repair:** Vines growing on exterior walls should be kept trimmed away from siding, window trims, and the eaves to reduce risk of insect and water damage.

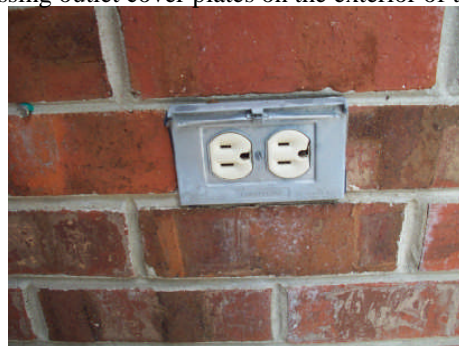
- **Repair:** Missing outlet cover plates on the exterior of the home should be replaced to avoid a shock hazard.

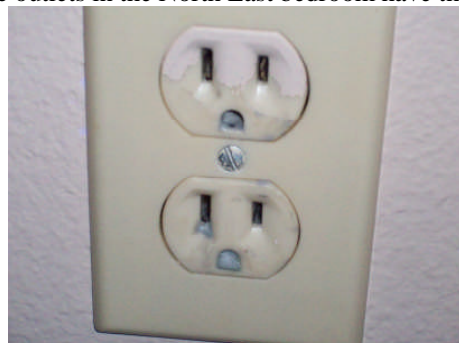
- **Repair:** Missing outlet cover plates in the family room should be replaced to avoid a shock hazard.
- **Repair:** The outlets in the North East bedroom have the something blocking the holes.

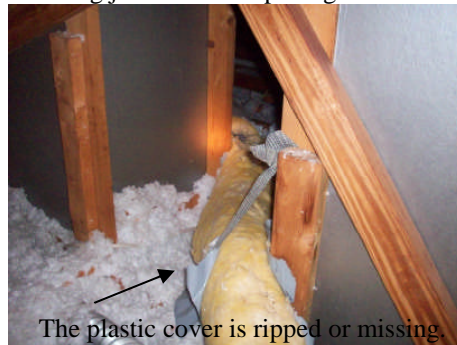
Supply Air Ductwork

- **Repair:** Loose fitting joints and/or openings in the ductwork should be improved.

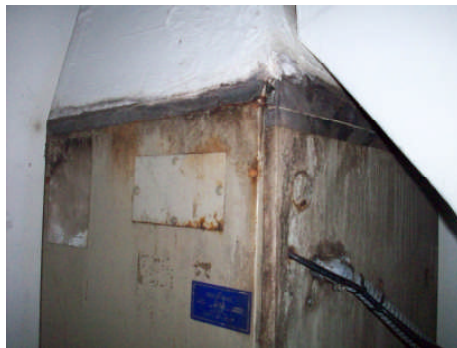
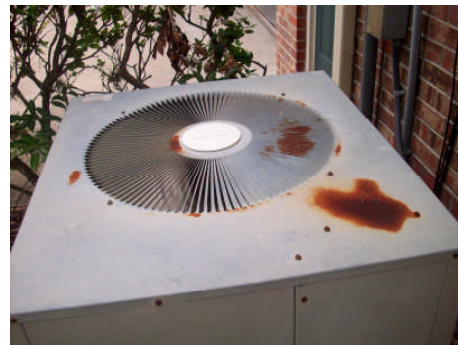
- **Repair:** As is not uncommon for homes of this age and location, the air conditioning system is relatively old. It will require a higher level of maintenance, and may be more prone to major component breakdown. Predicting the frequency or time frame for repairs on any mechanical device is virtually impossible. If the compressor fails, or if breakdowns become chronic, replacing the entire system may be more cost-effective than continuing to undertake repairs.

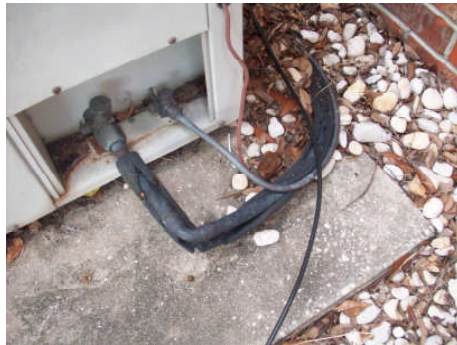
- **Monitor:** The temperature drop measured across the evaporator coil of the air conditioning system is lower than typical. This usually indicates that servicing is needed. A qualified heating and cooling technician should be consulted to further evaluate this condition and the remedies available.
- **Improve:** The air conditioning system requires servicing.
- **Repair:** Damaged insulation on refrigerant lines should be repaired.

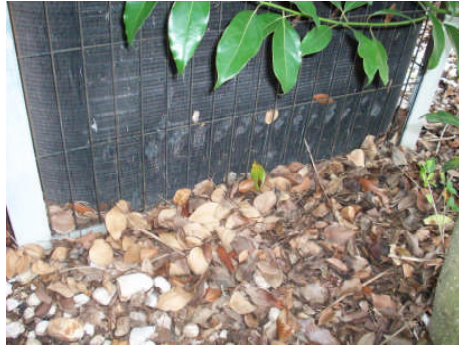
- **Improve:** The outdoor unit of the air conditioning system requires cleaning.

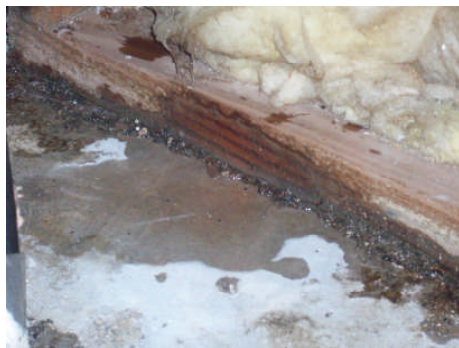
- **Repair:** Water was dripping into the return box from the coils.

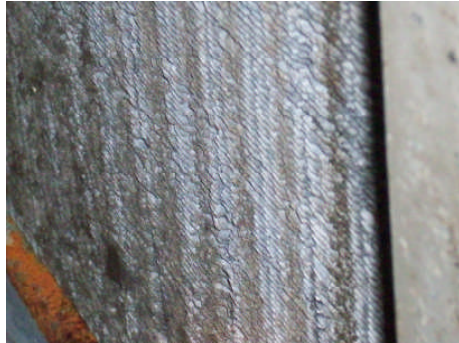
Evaporative Cooler

- **Repair:** The evaporative cooler has been lacking maintenance somewhat. A qualified heating and cooling technician should be consulted to further evaluate this condition and the remedies available.

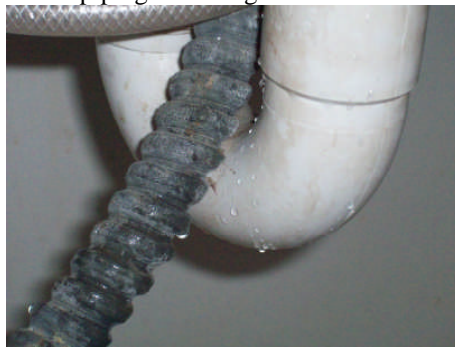
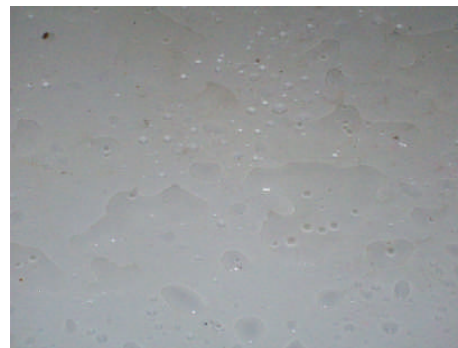
- **Repair:** The waste piping is leaking in the kitchen.

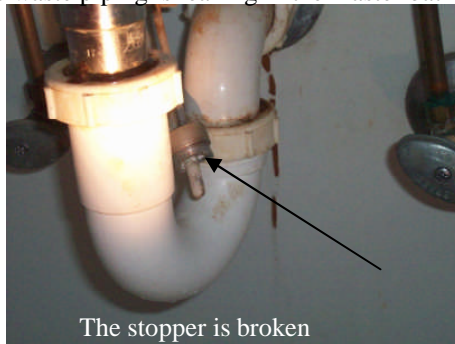
- **Repair:** The waste piping is leaking in the master bathroom.

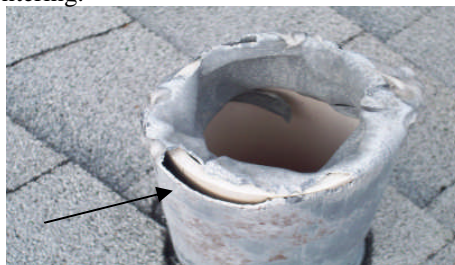
- **Repair:** The vent stack that penetrates the roof has vermin eating the lead covering. This should be sealed to prevent water from entering.

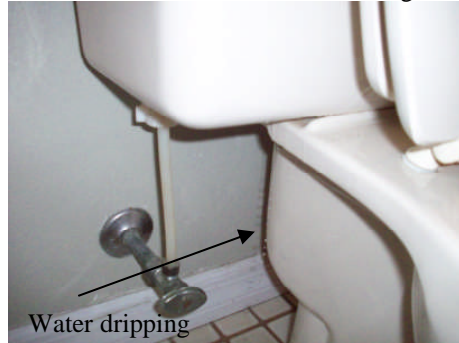
- **Repair:** The toilet in the master bathroom is leaking from the fill valve.
- **Repair:** The toilet in the main bathroom is leaking in between the tank and bowl.

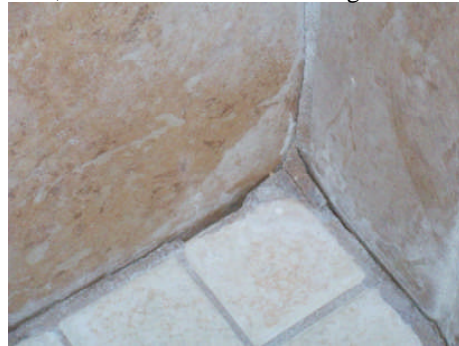
- **Repair:** Cracked, deteriorated and/or missing shower stall grout and caulk should be replaced in the master bathroom.

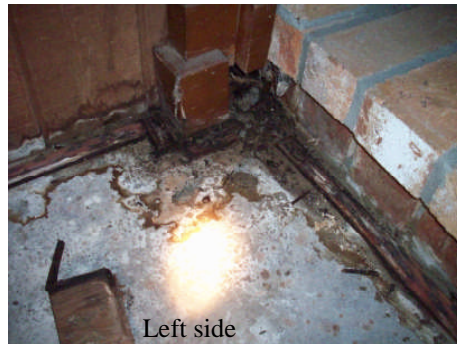
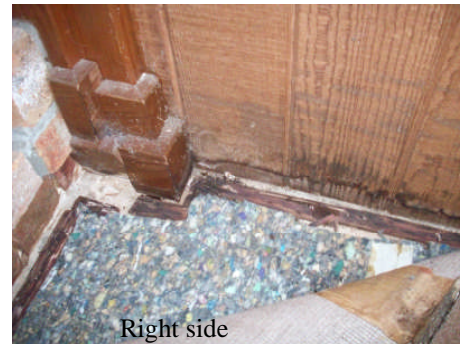
- **Monitor, Repair:** Water damage was noted on the left and right side of the fire place in the family room.

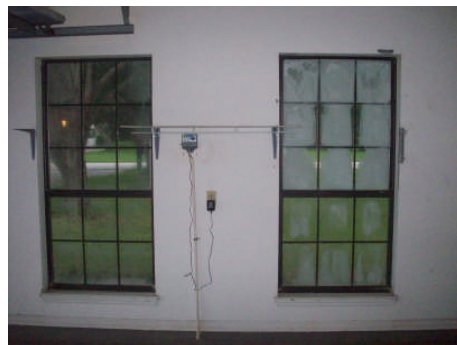
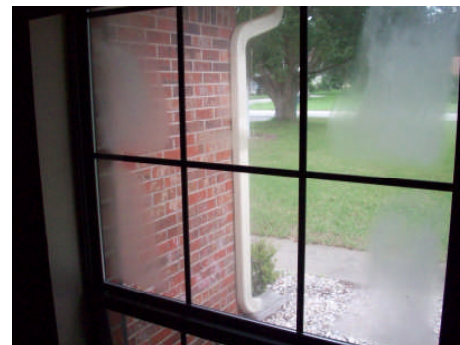
- **Monitor:** The window(s) have lost their seal. This has resulted in condensation developing between the panes of glass. This “fogging” of the glass is primarily a cosmetic concern, and need only be improved for cosmetic reasons.

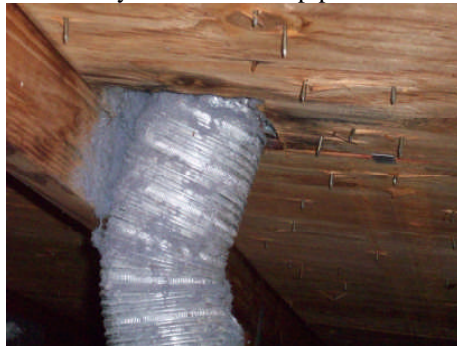
Clothes Dryer

- **Repair:** The clothes dryer exhaust vent pipe should be improved.

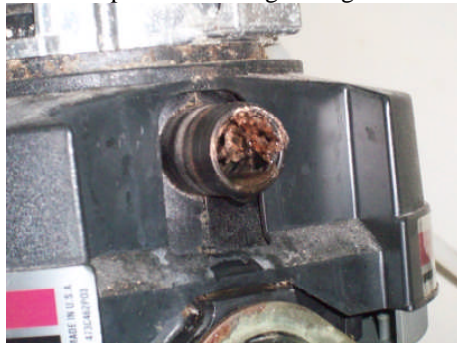
Waste Disposer

- **Repair:** The waste disposer is leaking through the dishwasher port.
